Fire Pumps

Hidden Damage in Fire Pumps

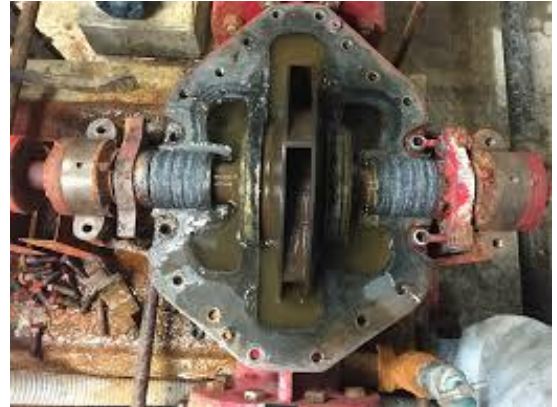
Figure 1 – Horizontal Split Case Pump Inspection

The rate of corrosion and resulting damage is difficult to gauge **unless the casing is removed**. If corrosion compromises the casing shape, the pumps performance will decline. Corrosion can also occur in the pump's stuffing box making successful shaft sealing difficult or impossible.

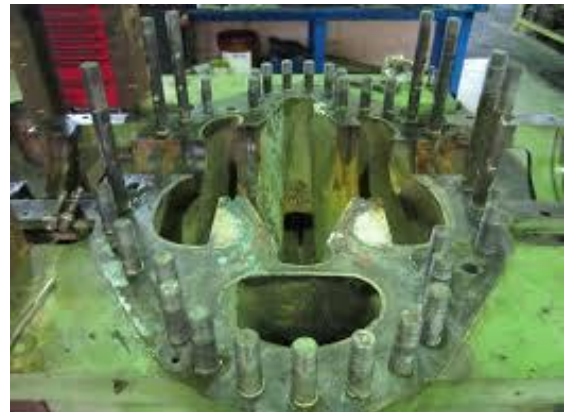
Figure 2 – Horizontal Split Case Pump Assessment

In order to determine if the pump is damaged, **the pump casing must be dis-assembled** and examined for corrosion and wear (See figure 2). Metal surfaces must be cleaned and the pump sleeve outside diameter must be checked to determine if it meets manufacturers specification. If it does not, it must be replaced.

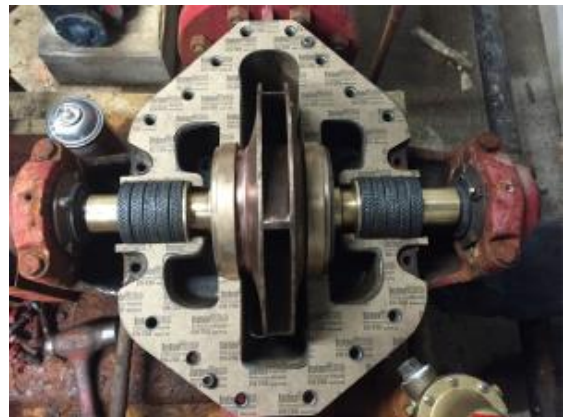
Figure 3 – Horizontal Split Case Pump Repaired

Mechanical packing mounted inside the stuffing box (See figure 3) must be loaded with a packing "gland" to enable intimate contact with the pump sleeve. This intimate contact causes wear on the pump sleeve over time. If the sleeve is substantially worn, then it must be replaced to effect a seal.

Mounted on each side of the impeller (See figure 3) are wear rings which are designed to inhibit re-circulation from the pump discharge to the pump suction. Corrosion around and erosion between these wear rings can allow re-circulation which will reduce pump performance. In this case these rings and the pump bearings must be replaced to re-establish the pumps performance. If the casing is badly corroded, pump replacement may be necessary.
