# Fire Pumps

## Hidden Damage in Fire Pumps

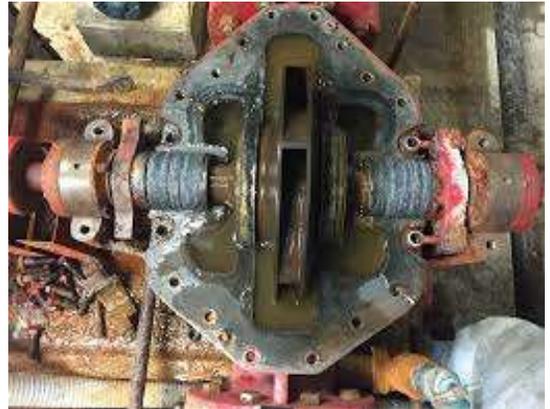
Figure 1 – Horizontal Split Case Pump Inspection

The rate of corrosion and resulting damage is difficult to gauge **unless the casing is removed**. If corrosion compromises the casing shape, the pumps performance will decline. Corrosion can also occur in the pump's stuffing box making successful shaft sealing difficult or impossible.

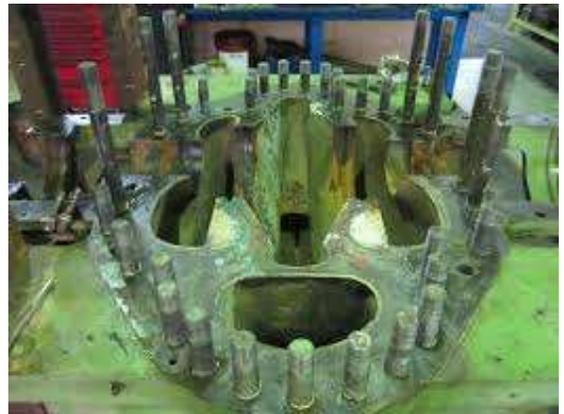
Figure 2 – Horizontal Split Case Pump Assessment

In order to determine if the pump is damaged, **the pump casing must be dis-assembled** and examined for corrosion and wear (See figure 2). Metal surfaces must be cleaned and the pump sleeve outside diameter must be checked to determine if it meets manufacturers specification. If it does not, it must be replaced.

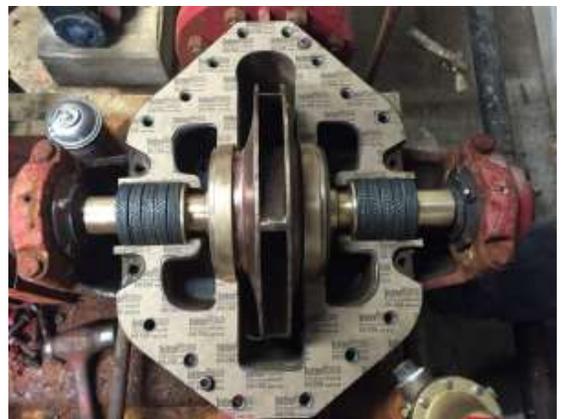
Figure 3 – Horizontal Split Case Pump Repaired

Mechanical packing mounted inside the stuffing box (See figure 3) must be loaded with a packing "gland" to enable intimate contact with the pump sleeve. This intimate contact causes wear on the pump sleeve over time. If the sleeve is substantially worn, then it must be replaced to effect a seal.

Mounted on each side of the impeller (See figure 3) are wear rings which are designed to inhibit re-circulation from the pump discharge to the pump suction. Corrosion around and erosion between these wear rings can allow re-circulation which will reduce pump performance. In this case these rings and the pump bearings must be replaced to re-establish the pumps performance. If the casing is badly corroded, pump replacement may be necessary.
